ECCO SHOES, BREDEBRO, DENMARK

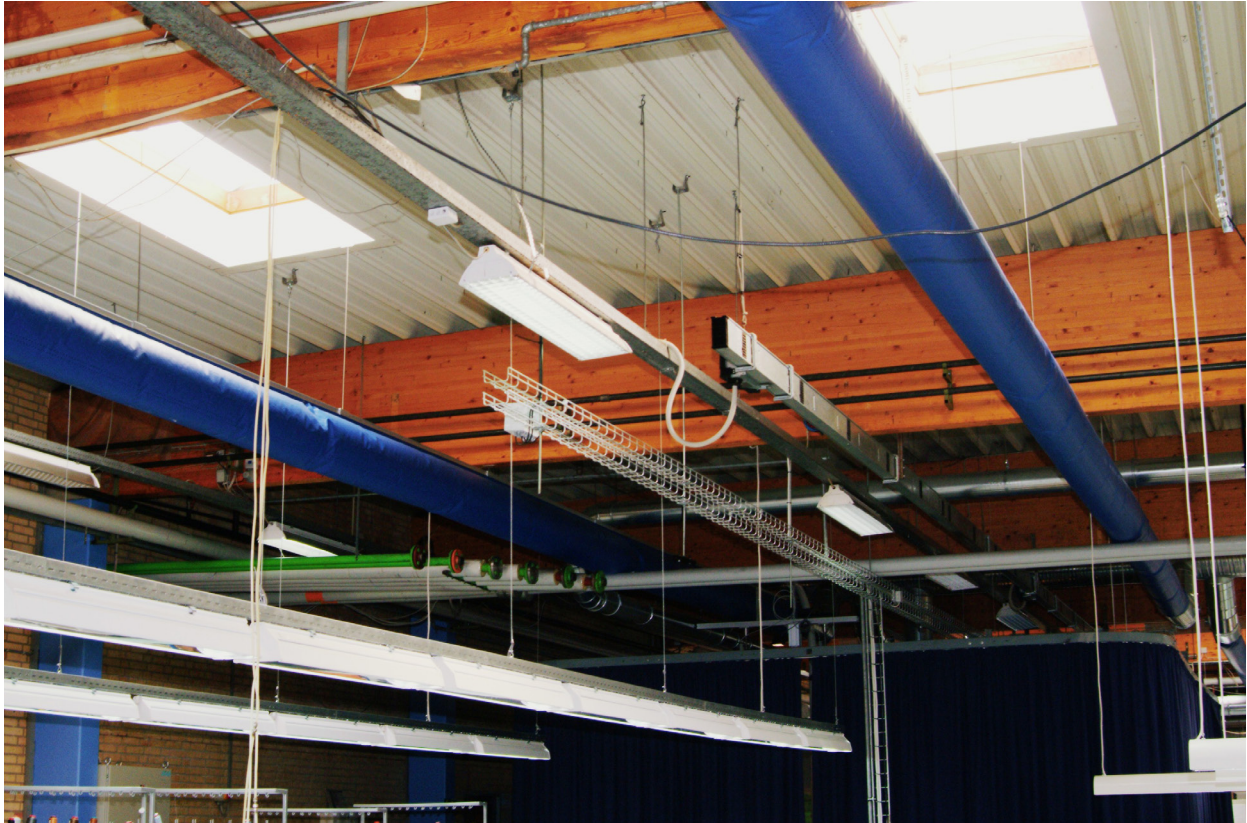
The solution was a Euro Air system with inject fabric ducts. The number of and the placement of the diffuser perforations are calculated specifically for each project, so it is possible to achieve a low air velocity, avoid draught and have a constant room temperature. A survey made after the installation has shown that the calculations done at the design stage were very accurate and that the employees at Ecco Shoes were very satisfied with the solution.

At Ecco shoes there was a problem with the indoor climate in one of the production areas because the room temperature could not be controlled. The problem was partly caused by a centrally mounted “carousel” where shoe components were glued and heat cured. In the wintertime the carousel proved a considerable heat source for the room, but in the summertime it made the room temperature much too high. In an attempt to alleviate the problem external air was being introduced but this was causing a draught.

Ecco Shoes decided to move the carousel to another area, which then created a need for additional wintertime heating in the affected room. In addition to all of this it was a central requirement that the velocities be reduced in the occupied zone at all times of the year.
